NASA TECHNICAL NOTE

NASA TN D-8411

EFFECT OF LOW-VELOCITY IMPACT DAMAGE ON THE COMPRESSIVE STRENGTH OF GRAPHITE-EPOXY HAT-STIFFENED PANELS

*Marvin D. Rhodes, Jerry G. Williams,
and James H. Starnes, Jr.*

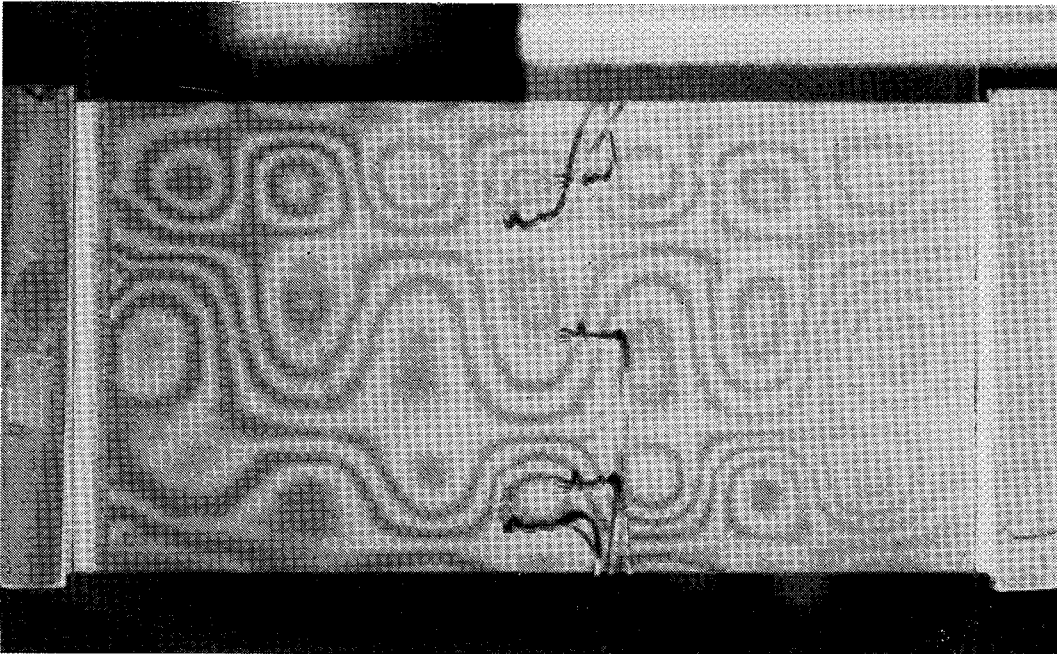
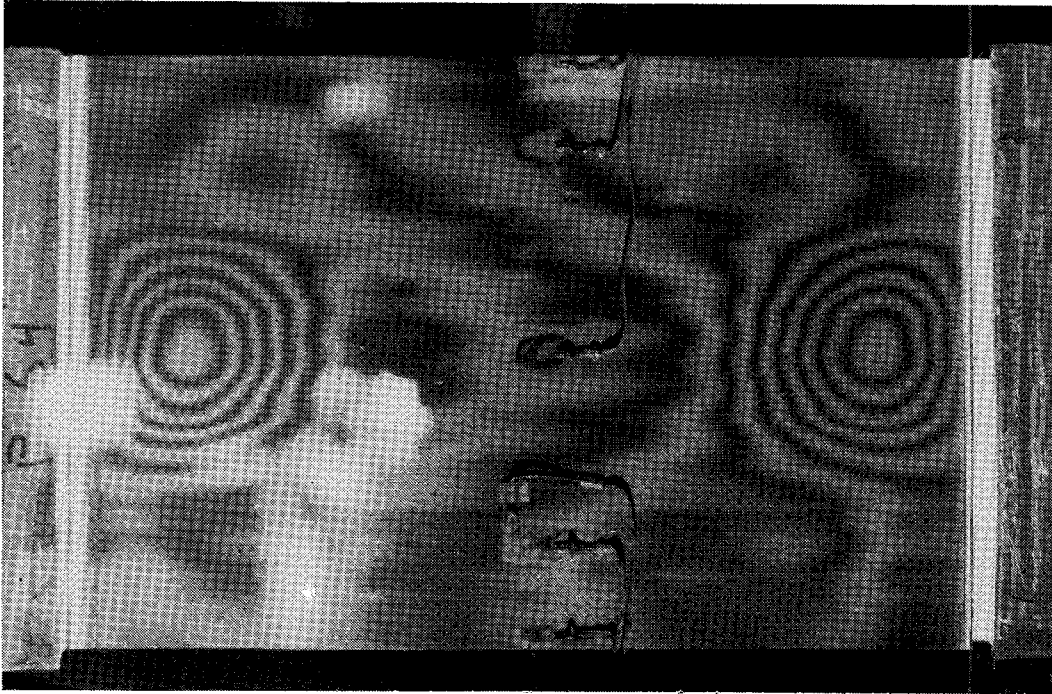
Undamaged panels.— Three panels of design A and four of design B were tested in the undamaged condition to evaluate panel behavior due to applied axial compressive load. The response of each panel to the indicated applied load, or strain, is presented in table II. The design A panels buckled near the design strain of 0.0034 and exhibited postbuckling behavior. The design B panels exhibited strength failure near the design strain of 0.0080 prior to buckling. Photographs of a typical normal displacement field as indicated by the moiré-fringe pattern for both design configurations are shown in figure 3. Test panel A1 (fig. 3(a)) has a fully developed buckle pattern at an imposed strain of 0.0036. Test panel B2 (fig. 3(b)) is shown at an imposed axial strain of 0.0079 which is near the strain at which the panel exhibited failure. The pattern seen at the ends of the panel is the result of in-plane restraints imposed by the flat-end test condition (ref. 2).

(a) Panel A1 designed for strain of 0.0034
loaded to strain of 0.0036.

(b) Panel B2 designed for strain of 0.0080
loaded to strain of 0.0079.

Figure 3.- Photographs of moiré-fringe patterns for typical undamaged panels
during compression tests.

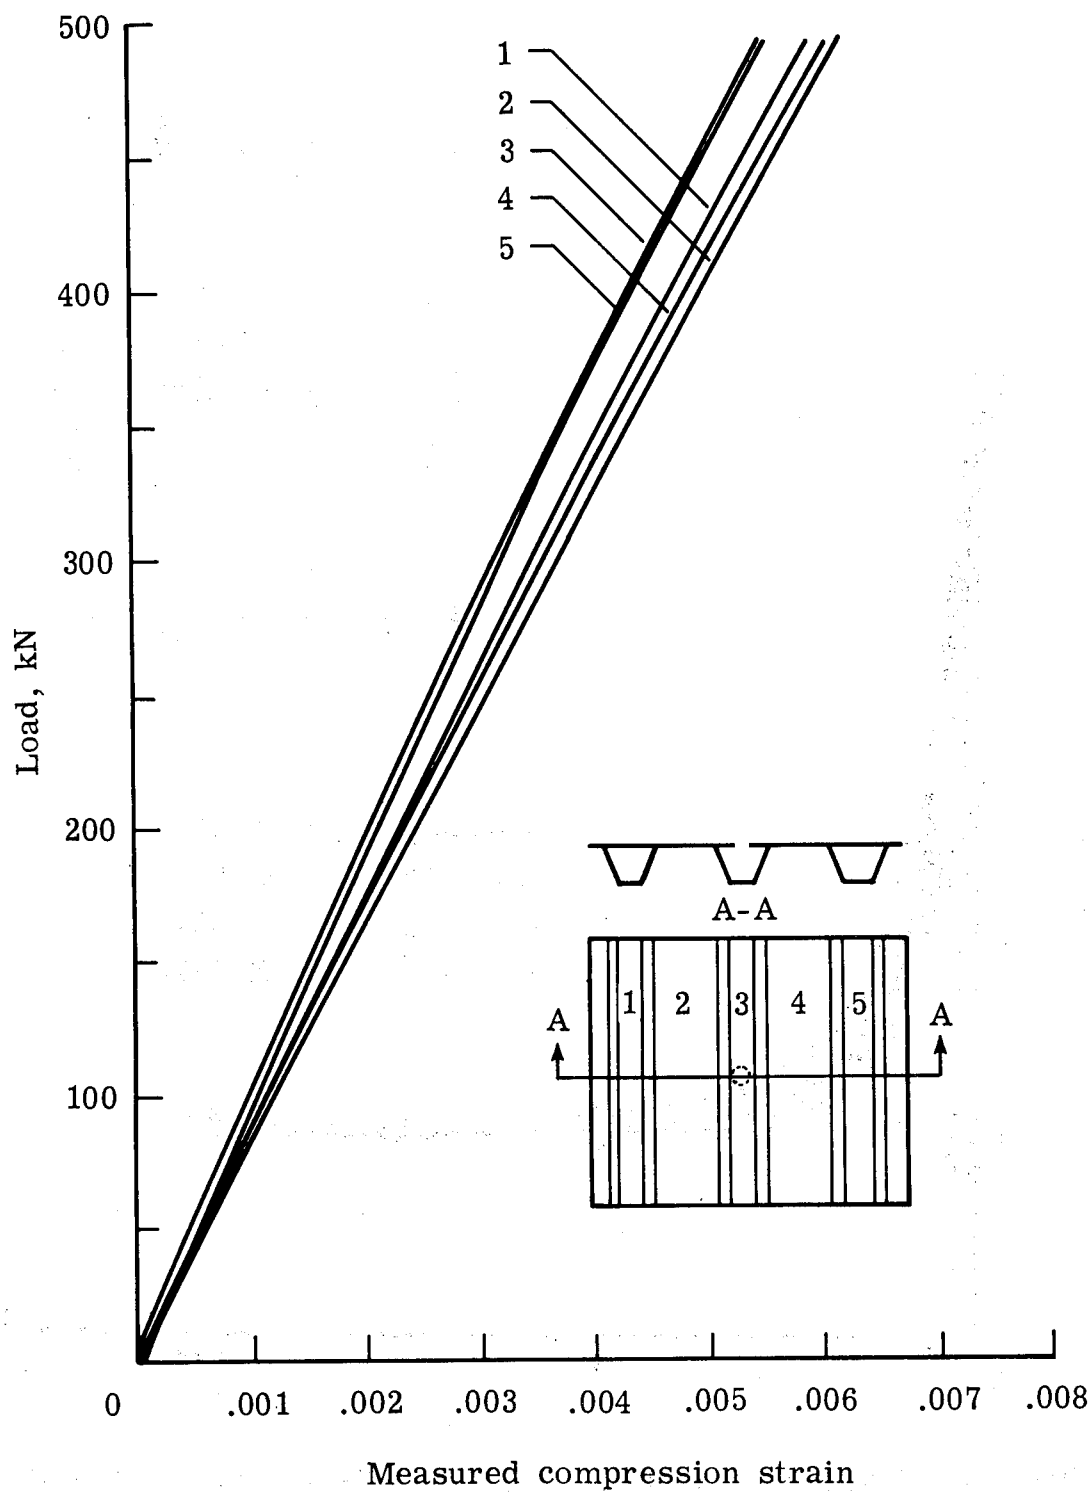
Panel with a cutout.— Panel B5 with the 1.27-cm-diameter cutout was loaded to failure in axial compression. Far-field axial strains were measured during the test by five strain gages located on a line across the panel, 6.35 cm from the cutout center. The locations of those gages and the strains as a function of load are shown in figure 4. These data indicate a nearly uniform far-field axial strain distribution across the panel and a linear load-strain relationship to failure. The average of these gages is referred to in this paper as the applied strain. Panel failure occurred at an applied strain of 0.0058 (applied load of 496 kN) which is 73 percent of the 0.0080 design strain.

Figure 4.- Compression load-strain curves at five locations across panel B5 which has 1.27-cm-diameter cutout in high-axial-stiffness region of center stiffener.

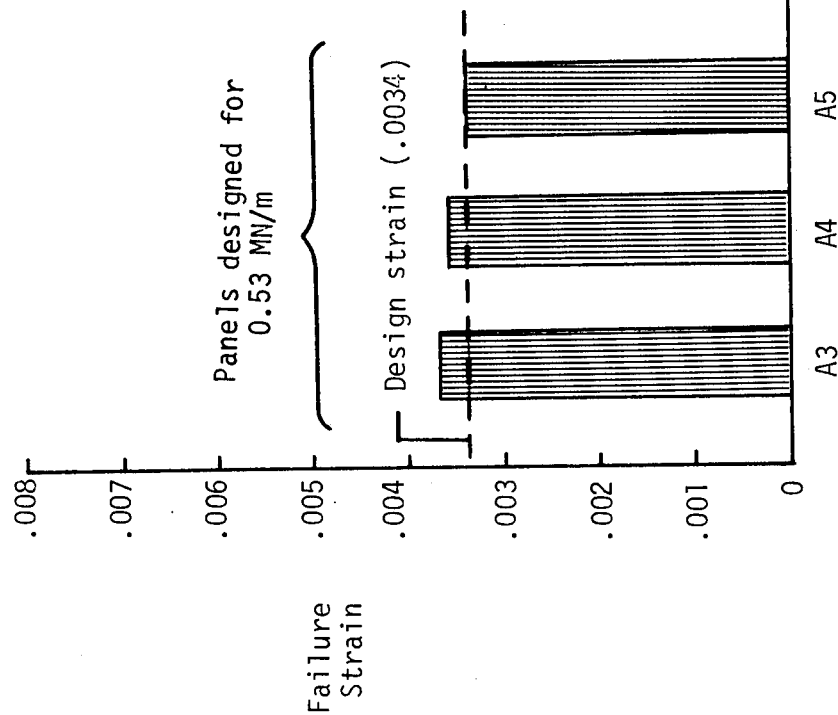
Impact-damage characterization: A comparison of test results for impact damage in the high-axial-stiffness region indicates both similarities and differences in the results for panels of design A and design B. The extent of local damage induced by impact increased with the magnitude of applied axial-compression strain for both designs. The design A panels satisfied the design-strain requirements with the presence of impact damage and also exhibited post-buckling behavior. The design B panels, however, failed due to impact damage at applied axial strains between 50 and 58 percent of the design strain level. Failure strains for impact-damaged panels and the control panel with circular cutout can be compared in figure 12. Limited local impact damage that was not noticeable by visual inspection (panel B6) reduced the ultimate strength of the design B panels as much as extensive visible localized damage (panel B7). All three of the design B panels damaged by impact failed at lower applied strain levels than the control test panel with the 1.27-cm-diameter cutout. The damaged region caused by impact, however, was larger than the cutout. For all design B panels the damage in the high-axial-stiffness region precipitated failure at an applied strain well below the design strain level.

Figure 12.- Failure strains for panels damaged by impact in high-axial-stiffness region and for control panel.
